WLAN-Funkmodule Flash-Anleitung (Display280, Kabel)

Version 1.0 // 29.8.2022

Anleitung zum Flashen des Display Moduls 280

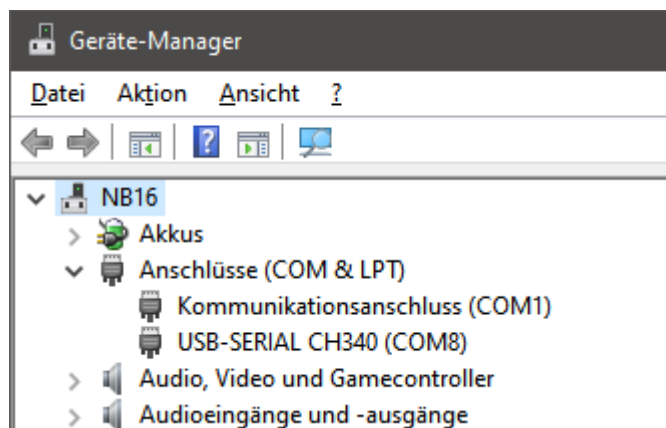
Im Bereich "Anschlüsse" sollte ein neue Eintrag vorhanden sein, welcher die Schnittstelle ("USB-SERIAL") zum Display bezeichnet.

In diesem Beispiel ist das Display mit dem Anschluss **COM8** verbunden. Merken Sie sich diese Schnittstellenummer.
